Five-Year Review Report (Third) Five-Year Review United Chrome Products Site Corvallis, Oregon March 2003

United Chrome Products

Benton County, Oregon

March 2003

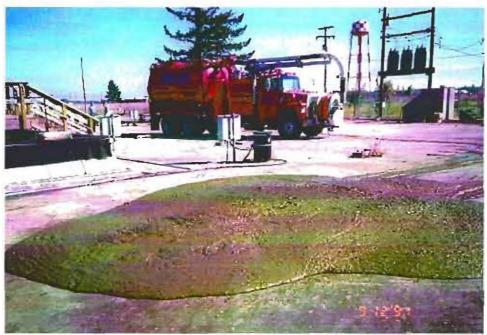
Photograph 8 – Chromium-contaminated sediment removed from onsite culvert in September 1991. The City attempted to stabilize the sediment with concrete to permit disposal at Subtitle D (nonhazardous) landfill, but was unable to blend the concrete and sediment into a stable solid.

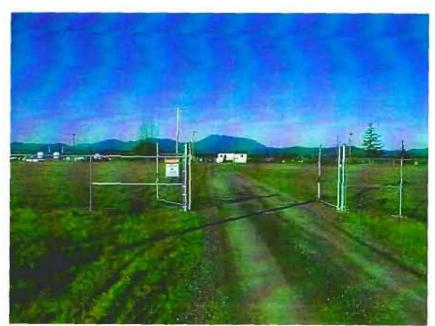
Two security fences (Photograph 10) enclose the United Chrome site, with access obtained through gates located off Airport Place. The outer fence, maintained by the Federal Aviation Administration, encloses the Corvallis Airport and is labeled with no trespassing and warning signs approximately every 100 feet along its entire length. The inner fence encloses the United Chrome and CoEnergy sites (Figure 6-1), which lie within the Corvallis Airport property. A third fence separates the United Chrome and CoEnergy sites from one another, and separate locking gates control entry and egress from each. CoEnergy also uses two guard dogs to patrol their facility.

Photograph 10 - FAA security fence outside United Chrome site fence.

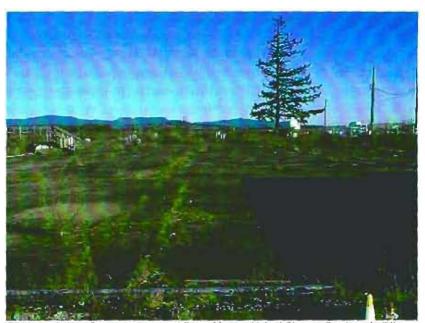
Photograph 11 - Concrete cover and floor of former United Chrome Products building.

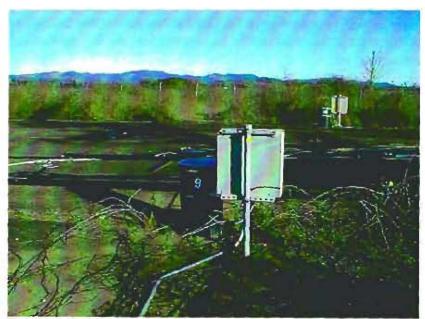
Photograph 12a - Upper zone extraction well EW-9.

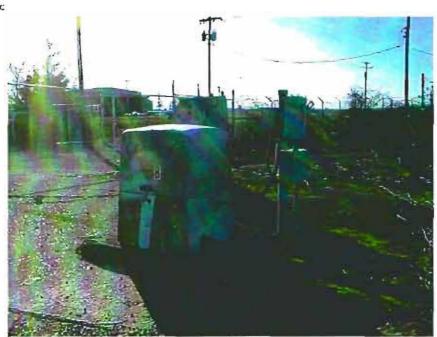
Photograph 12b - Deep aquifer extraction well DW-8.

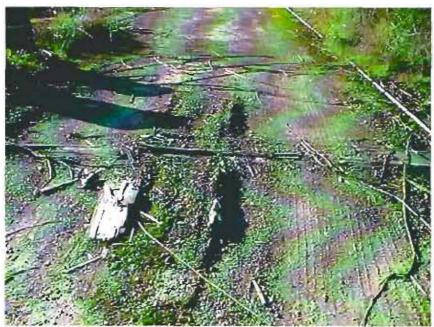
The above ground piping that conveys groundwater from extraction wells EW-9, DW-8, and DW-9 to the discharge point is in good shape. However, the bridge near wells EW-5 and DW-1 (Photograph 13), which allows vehicles to drive safely over the pipe, is in poor condition and should be repaired if future vehicle traffic through this area is required. The bridge was damaged by heavy truck traffic during the October 2000 upper zone source removal project.

Photograph 13 - HDPE aboveground pipe bridge near DW-1.

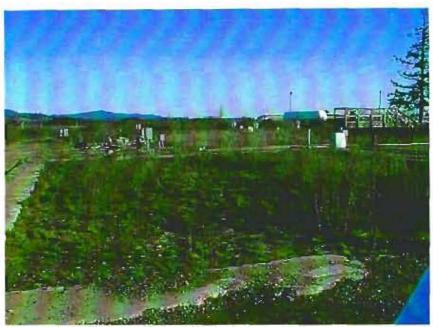
The infiltration basins (Basin 1 and Basin 2) were decommissioned in August 2000 in conjunction with the upper zone source removal work (Photograph 14). The decommissioning effort included removal of geotextile material, above-grade concrete walls, plumbing and valve controls. The infiltration trench is still operational but has not been used since January 1993, except for a short trial between August and October 2001. Given the limited nature of current upper zone pumping operations, it is unlikely the trench will be required in the future.

Photograph 14 - Footprint of former infiltration basin number 2.

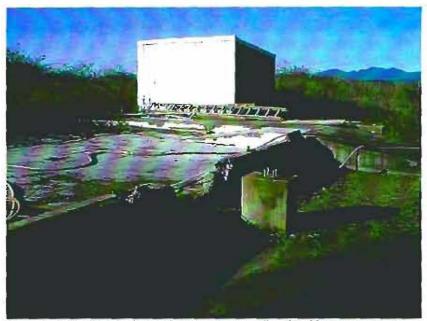
The groundwater treatment system was removed between March and April 1999. The only components remaining are the secondary containment wall that enclosed the influent tank storage and treatment system areas, the partially enclosed shop, the electrical control panel, the decontamination pad, and the containment cell for the sludge thickening tanks. The secondary containment wall has been intentionally breached (Photograph 15) along the north side to prevent accumulation of large amounts of rainwater. The metered discharge point where extracted groundwater is discharged to the sanitary sewer is in satisfactory condition (Photograph 16).

Photograph 15 – Breach of secondary containment wall at site of former wastewater treatment system.

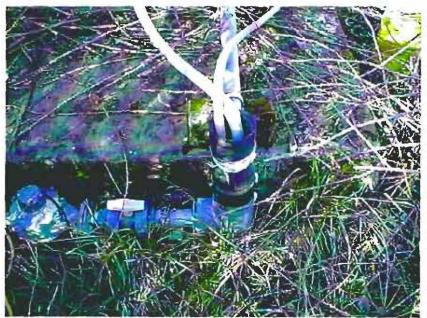
Photograph 16 - Upper zone and deep aquifer extracted groundwater discharge point.

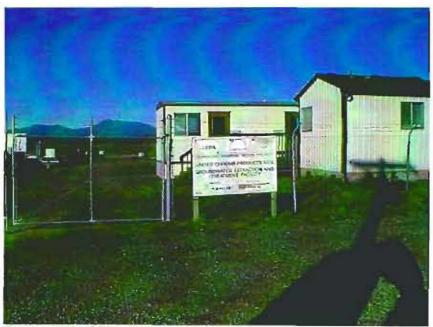
An office and laboratory trailer and locker room trailer, constructed as part of the groundwater remedial construction effort, are still maintained by the City of Corvallis (Photograph 17). All onsite testing is done in the laboratory trailer, but most document/data management is performed at the City of Corvallis POTW. The laboratory equipment appeared to be in good working condition, and the City provides copies of all calibration and quality assurance checks with the quarterly progress reports. Copies of the O&M manuals, health and safety plan, and historical site-related documents are also kept onsite. The O&M manual has not been updated since the treatment system was decommissioned in April 1999. However, to support an update to the site Health and Safety Plan, the City prepared a summary of significant site events (see Attachment 4 in Appendix A).

Photograph 17 - Office and laboratory trailer.

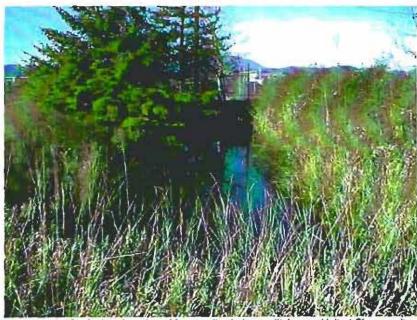
Photograph 18 – Isolated portion of former site drainage ditch near United Chrome site.
